2020 Site F Landfill Annual Inspection Report

Texas Municipal Power Agency
Gibbons Creek Steam Electric Station
Anderson, Texas
Project # 6706190003.70

2020 CCR Landfill Annual Inspection Report
Site F Landfill
Texas Municipal Power Agency
Gibbons Creek Steam Electric Station
Anderson, Texas

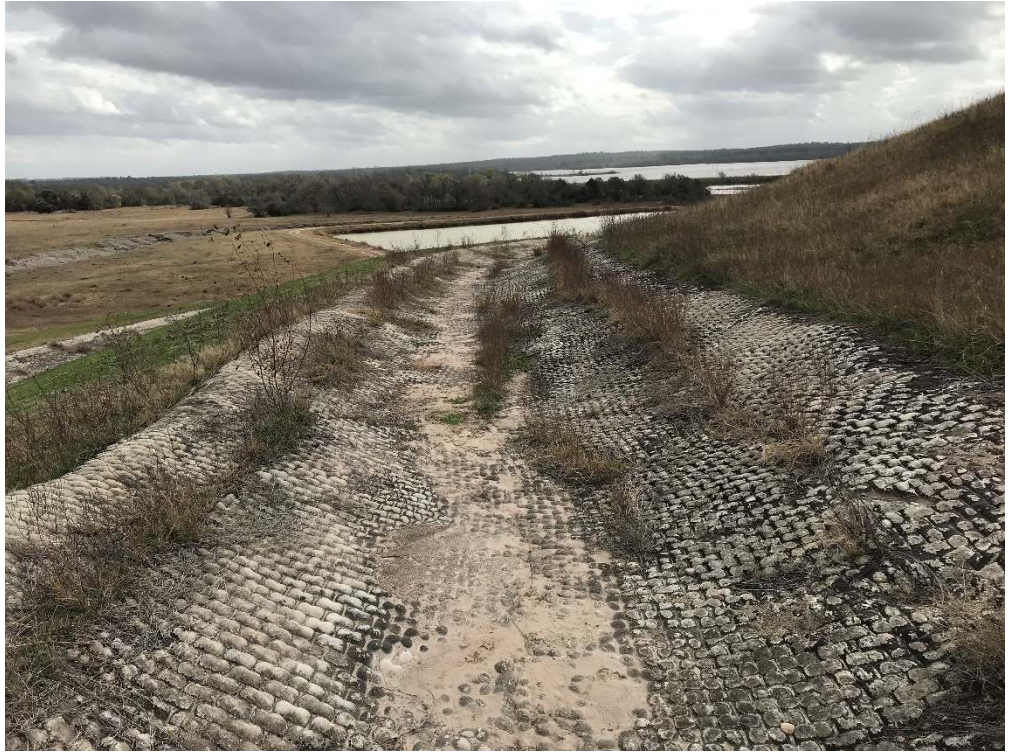
Photo No.: 1 **Date:** 01/09/2020

Description:
Typical vegetation and
sediment observed in the
fabric-formed concrete
drainage ditch.

The stormwater management systems of the SFL appears to be in good working order. Stormwater management around the SFL consists of run-off ditches and concrete-lined spillways directing water from the Cover Area and diverting water from entering the Active Area. Stormwater is directed to SFL Pond 1 and an unnamed stormwater retention pond via concrete-lined spillways and drainage ditches. The ditch bordering the northern side of the Active Area directs storm water to the small stormwater detention pond. Vegetation growing in portions of the concrete-lined spillways should continue to be removed as part of TMPA's routine maintenance operations.

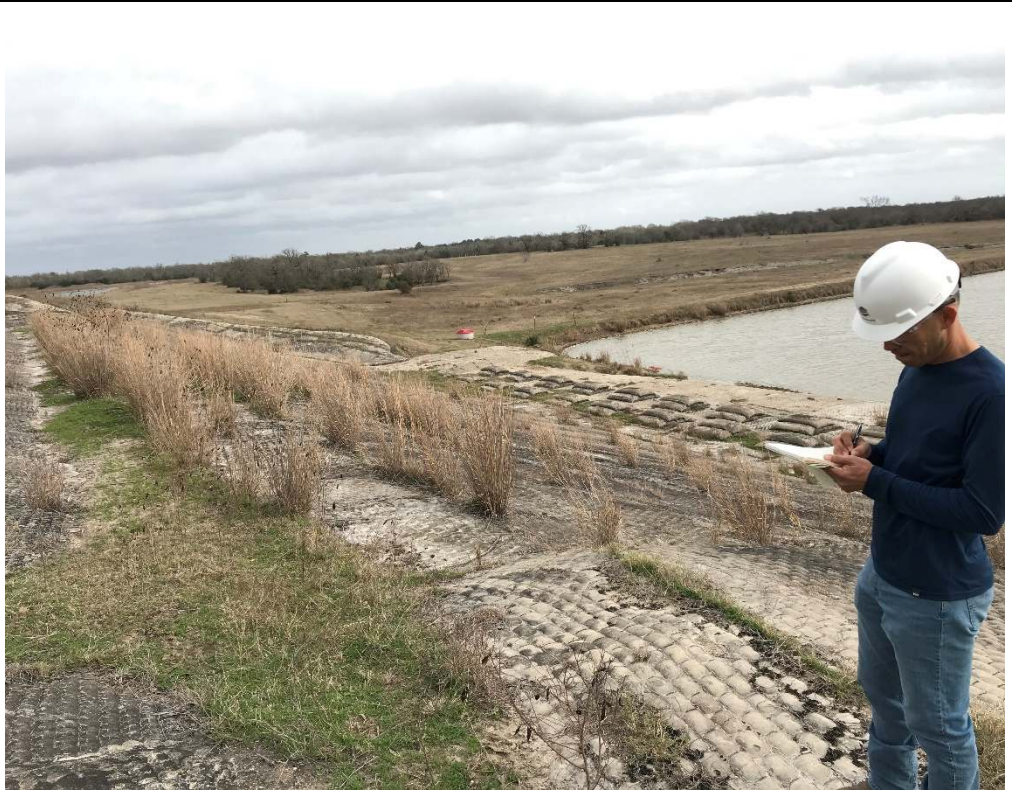
Photo No.: 2 **Date:** 01/09/2020

Description:
Significant vegetation
growing through the
concrete Stormwater
spillway.

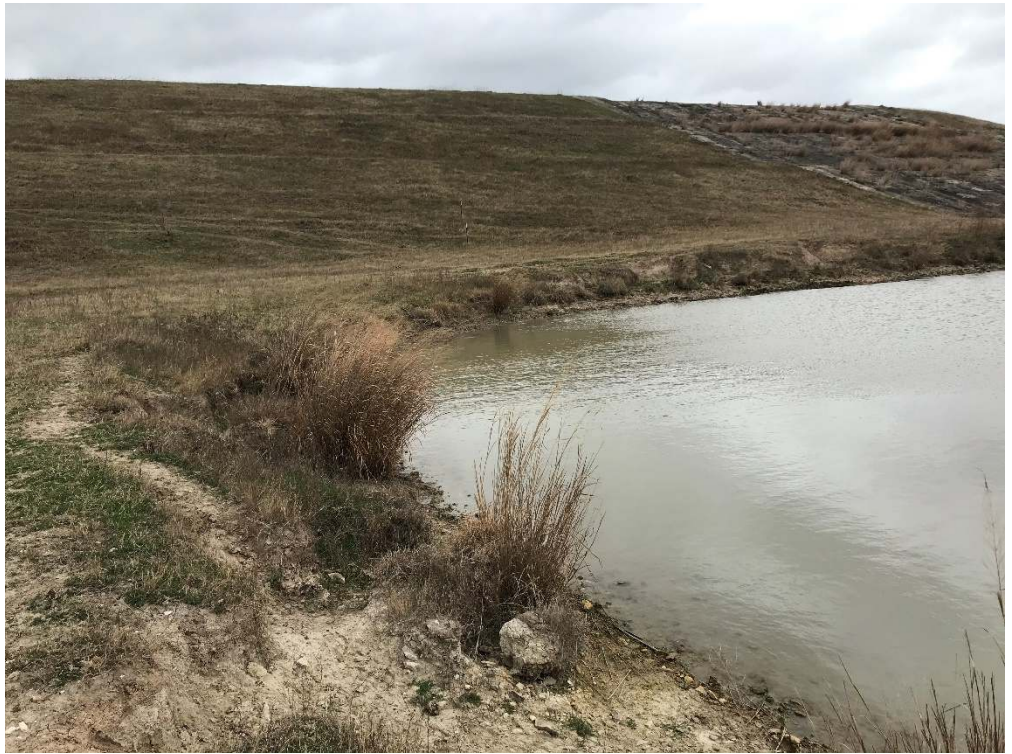
Facility: SFL Pond 1	
Photo No.: 3	Date: 01/09/2020
Photo Direction: NW	
Description: Typical erosion on interior slopes of SFL Pond 1 and Pond 3.

No areas of major erosion were observed at the time of inspection. Evidence of minor erosion was observed at various locations on the embankment slopes of the Cover Area and the Active Area. These areas and other areas with exposed soil should be regraded and seeded to allow vegetation growth and prevent further progression of erosion in these areas.

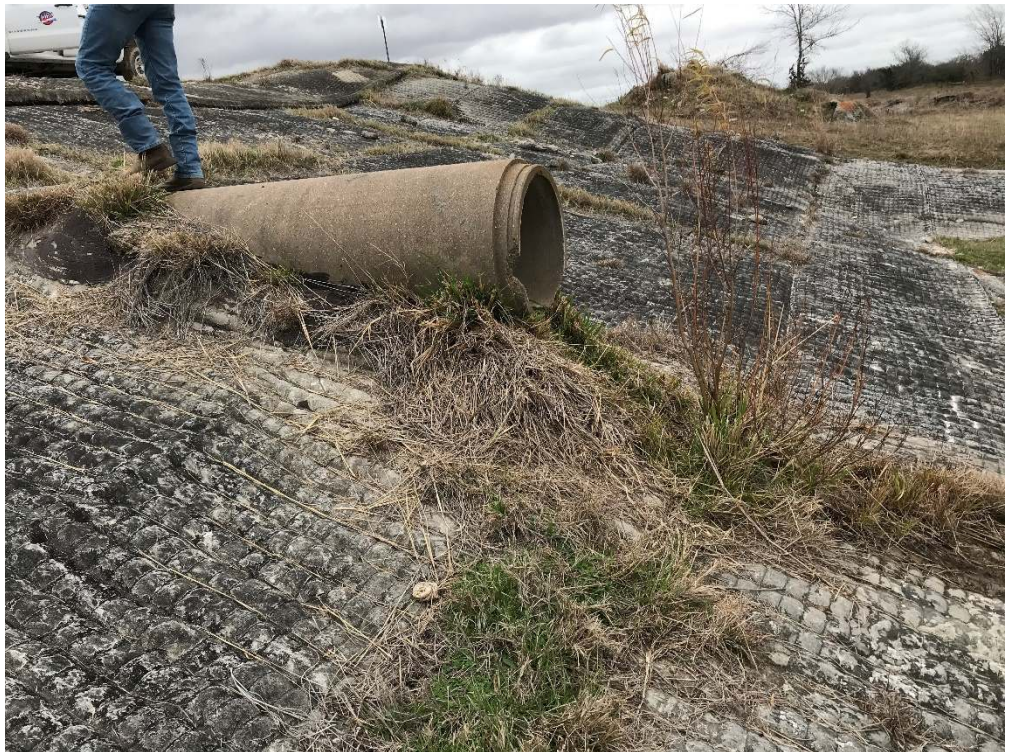
Facility: SFL Pond 1	
Photo No.: 4	Date: 01/09/2020
Photo Direction: N	
Description: Condition of concrete outlet pipe in SFL Pond 1.

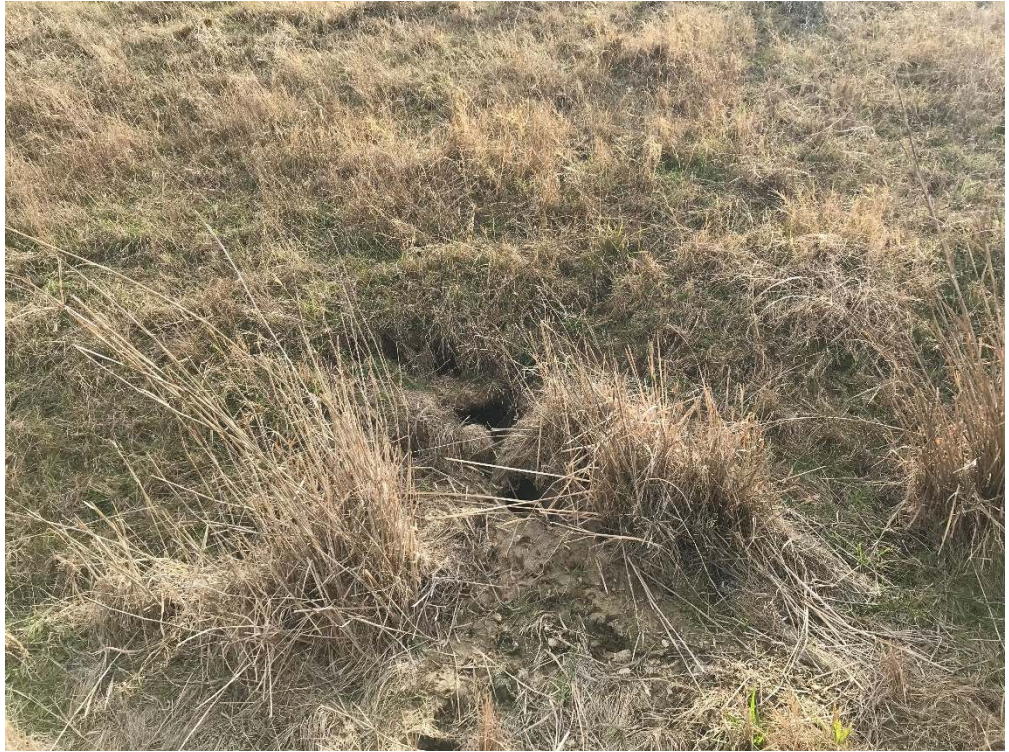
Facility: SFL Cover Area Embankment Slopes	
Photo No.: 5	Date: 01/09/2020
Photo Direction: E	
Description: Typical animal activity, indicative of otter burrows observed on west and north SFL Embankment slopes.

Three types of minor animal activity (possible otter and gopher burrows and cow paths) were observed at various locations along the landfill. The existing burrows should be addressed in accordance with the existing TMPA management plan as part of the routine maintenance. Future burrows should be addressed in a timely fashion as they are observed. With regard to cow paths, current efforts are in place to force the cows to change paths periodically to avoid deterioration of the vegetation along these paths. Remedial efforts were observed in the form of tires, and barbed wire across existing paths. These efforts appear to be an effective method to redirect cows. In addition to the current fixes, we recommend that the areas of previous cow paths be re-graded and seeded to promote soil growth and prevent erosion in areas with exposed soil.

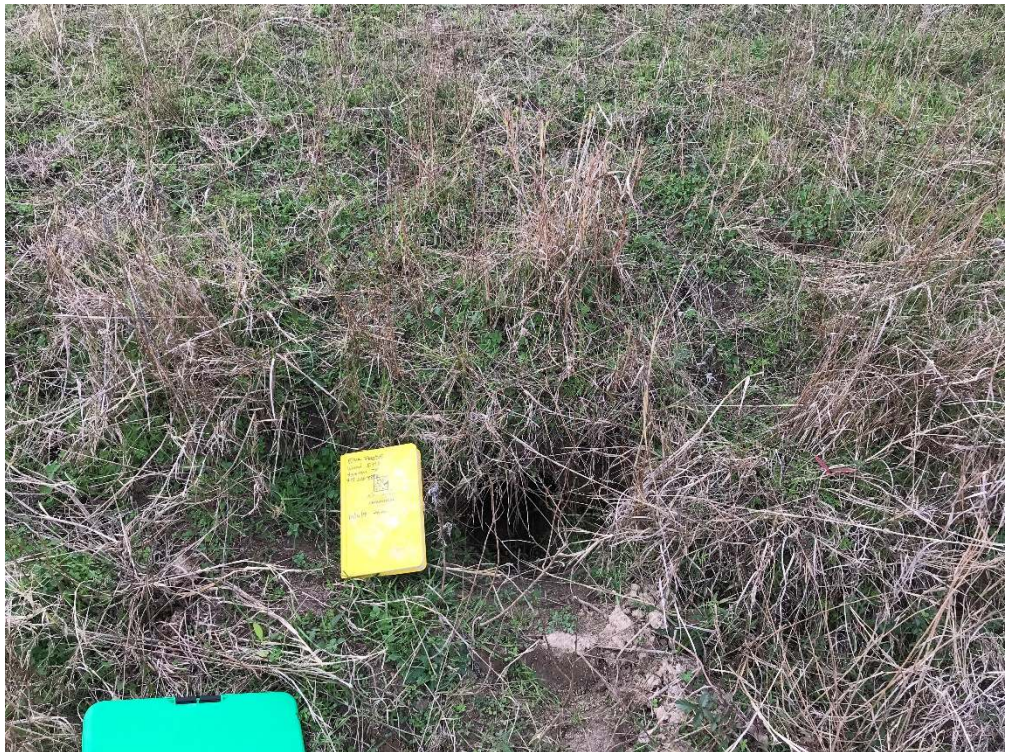
Facility: SFL Cover Area Embankment Slopes	
Photo No.: 6	Date: 01/09/2020
Photo Direction: S	
Description: Typical animal activity, indicative of otter burrows observed on west and north SFL Embankment slopes.

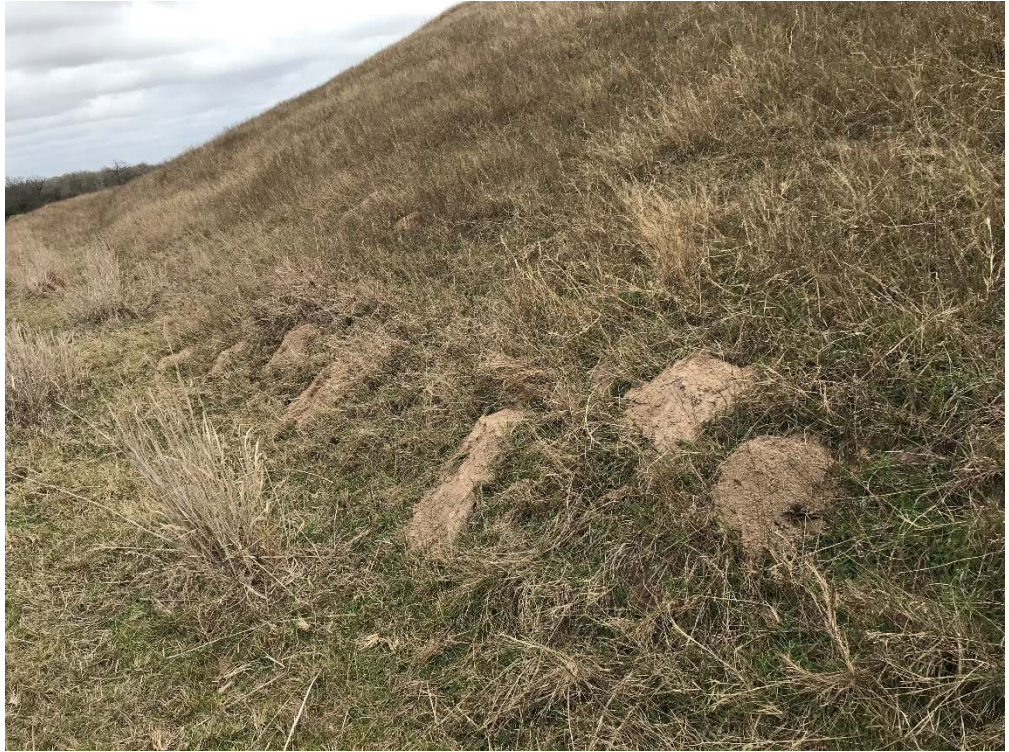
Facility: Active Area Southeast Embankment	
Photo No.: 9	Date: 01/09/2020
Photo Direction: SW	
Description: Typical animal activity, indicative of gopher holes observed the downstream side of the southeast embankment bordering the Active Area.

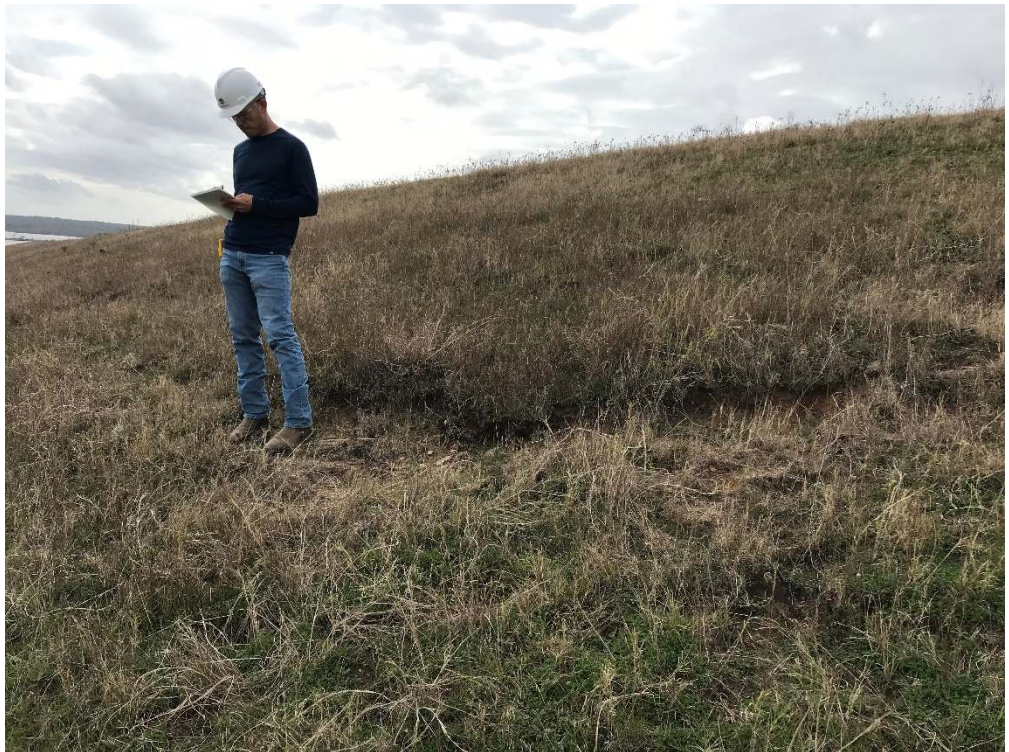
Facility: SFL Cover Area North Embankment	
Photo No.: 10	Date: 01/09/2020
Photo Direction: SE	
Description: Typical photo of erosional feature observed on the north embankment

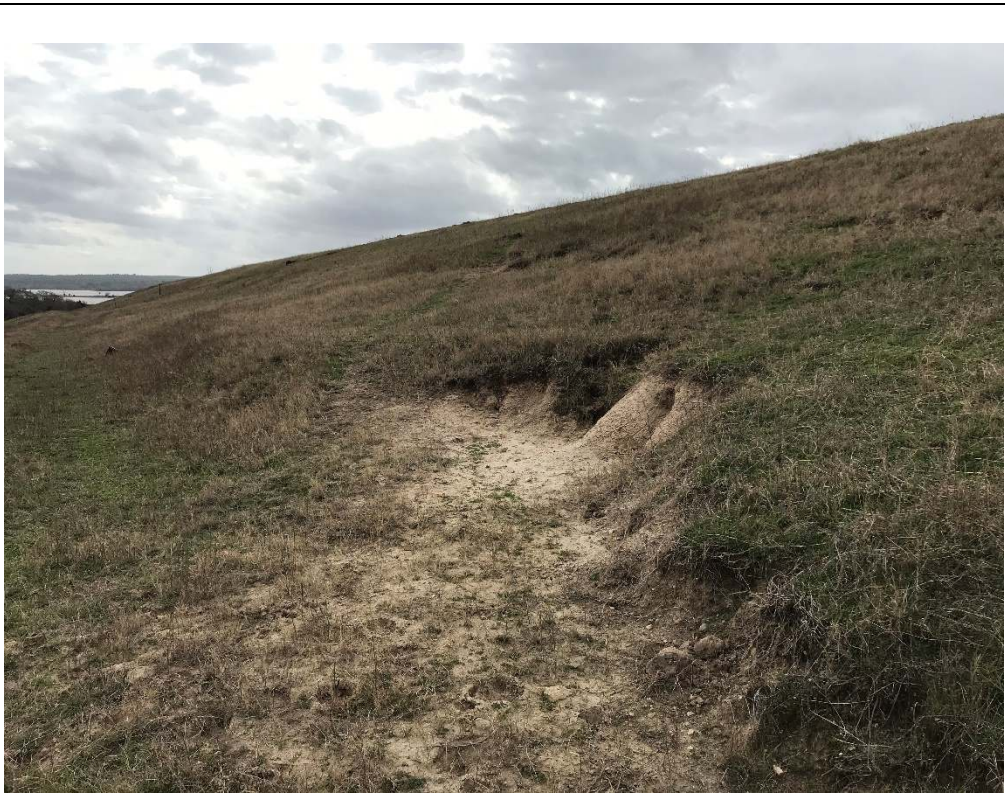
Facility: SFL Cover Area North Embankment	
Photo No.: 11	Date: 01/09/2020
Photo Direction: SE	
Description: Typical photo of erosional feature observed on the north embankment

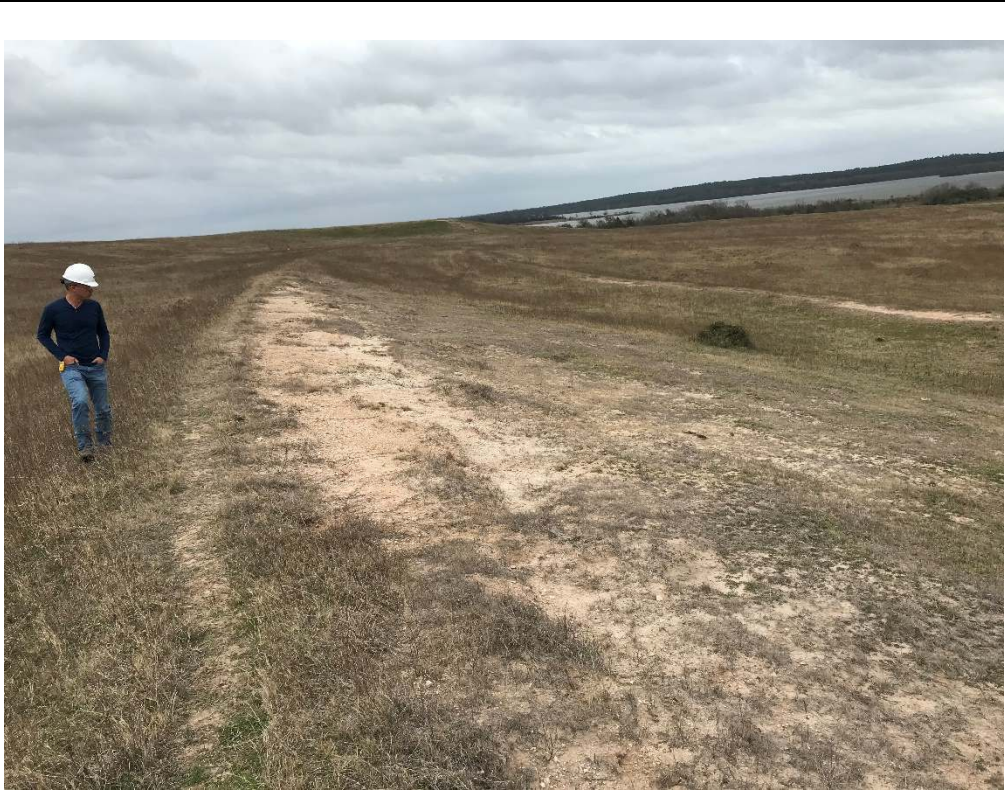
Facility: SFL Cover Area Southeast Embankment	
Photo No.: 12	Date: 01/09/2020
Photo Direction: NE	
Description: Typical photo of erosional feature observed on the southeast embankment

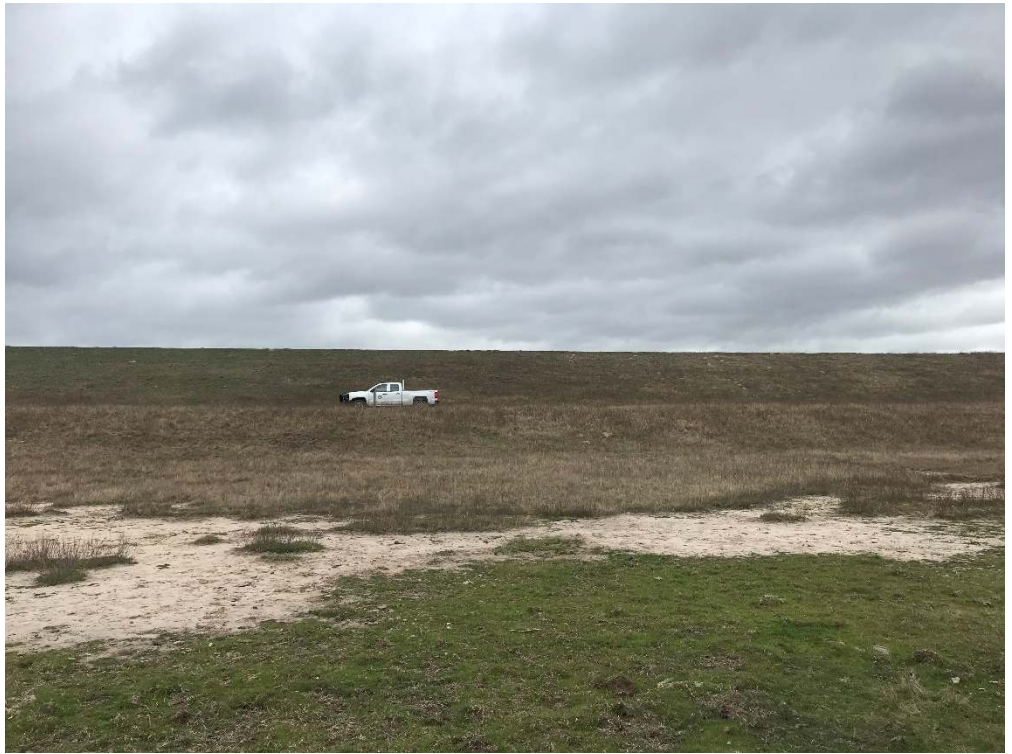
Facility: SFL Active Area Southeast Embankment	
Photo No.: 13	Date: 01/09/2020
Photo Direction: NW	
Description: Typical photo of erosional feature observed below the southeast embankment of the active area.

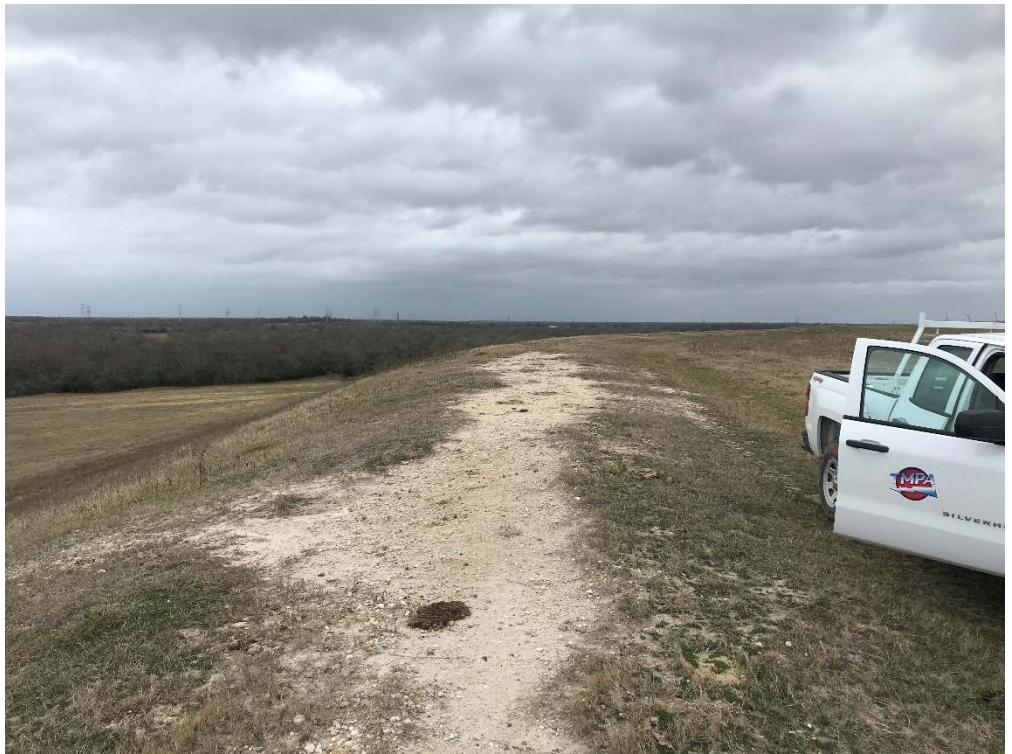
Facility: SFL Cover Area Embankment Crest	
Photo No.: 14	Date: 01/09/2020
Photo Direction: NE	
Description: Typical photo of erosional feature observed at various locations along the crest of the SFL Cover Area.

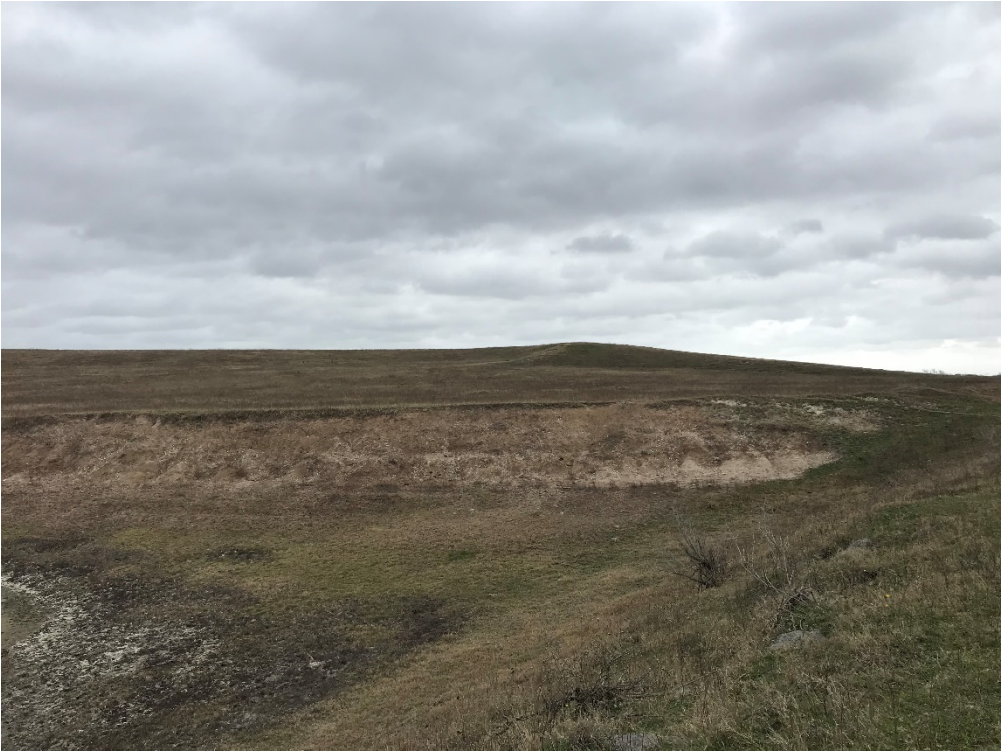
Photo No.: 15		Date: 01/09/2020
Photo Direction: N		
Description: Typical photo of erosion observed on the interior embankment at the northeast end of the Active Area.		
Facility: SFL Active Area Interior Slopes

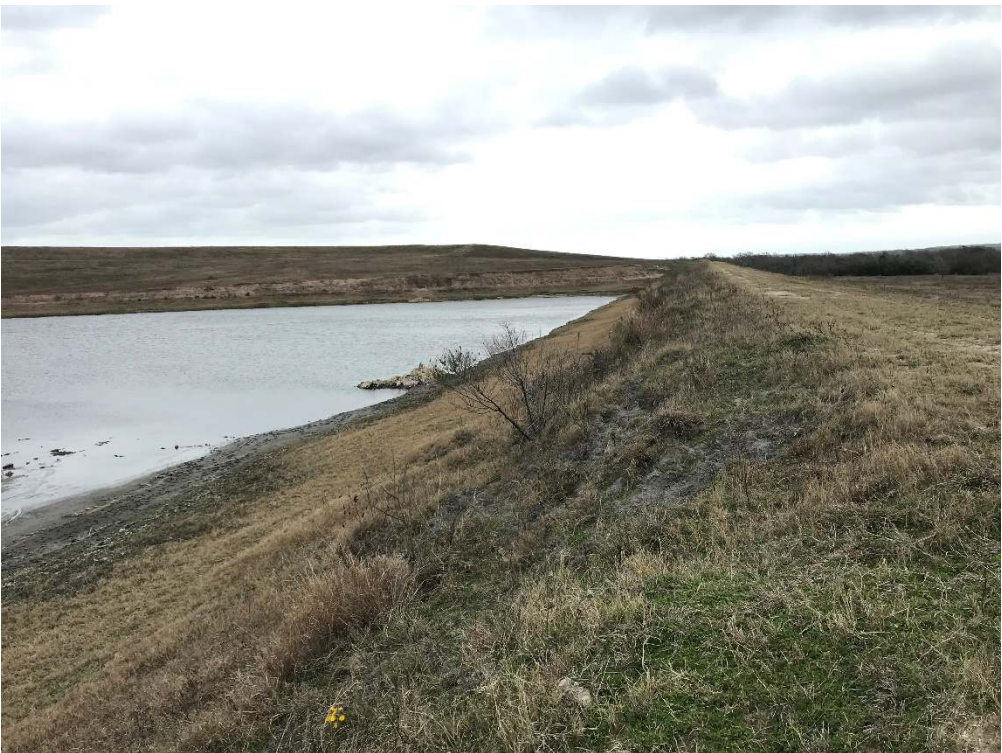
Photo No.: 16		Date: 01/09/2020
Photo Direction: NE		
Description: Typical photo of woody vegetation growth on interior embankment slopes.

Overall, the SFL's vegetative ground cover appeared to be adequately maintained as evidenced by the established vegetation on the slopes and the covered portion of the landfill. Minor vegetation was observed in the Active Area and appears to be properly maintained. Woody vegetation should continue to be removed from the interior slopes during regular maintenance operations.

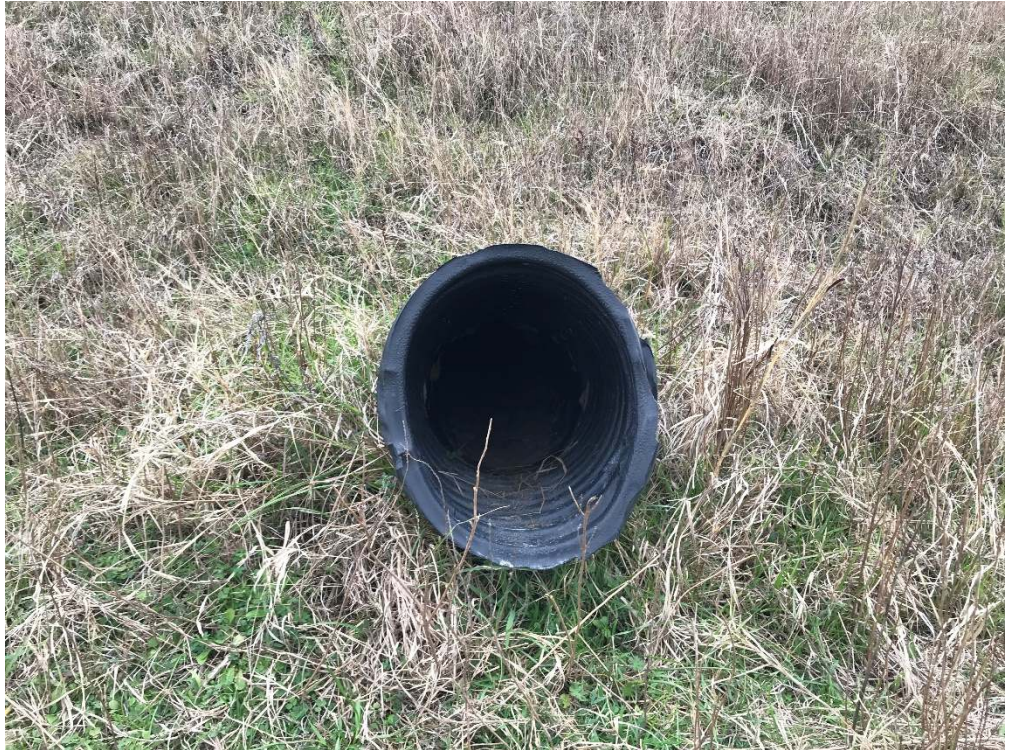
Plastic pipes were observed at various locations on the embankment slopes of the Cover Area. The pipes appeared to be outlet pipes; however, inlet locations for these pipes were not observed. We understand from conversations with plant personnel that the length of these pipes is at least 10-11 feet, and soil infilling was observed in

Facility: SFL Cover Area Embankment Slopes	
Photo No.: 17	Date: 01/09/2020
Photo Direction: E	
Description: Typical photo of corrugated plastic pipe observed on the embankment slopes of the Cover Area.

several of the pipes. Currently, the purpose of these pipes is not known. We recommend that purpose of these pipes be determined, and documentation should be reviewed to assess the nature of these pipes. We understand TMPA is working to find documentation related to the installation and purpose of these corrugated plastic pipes.

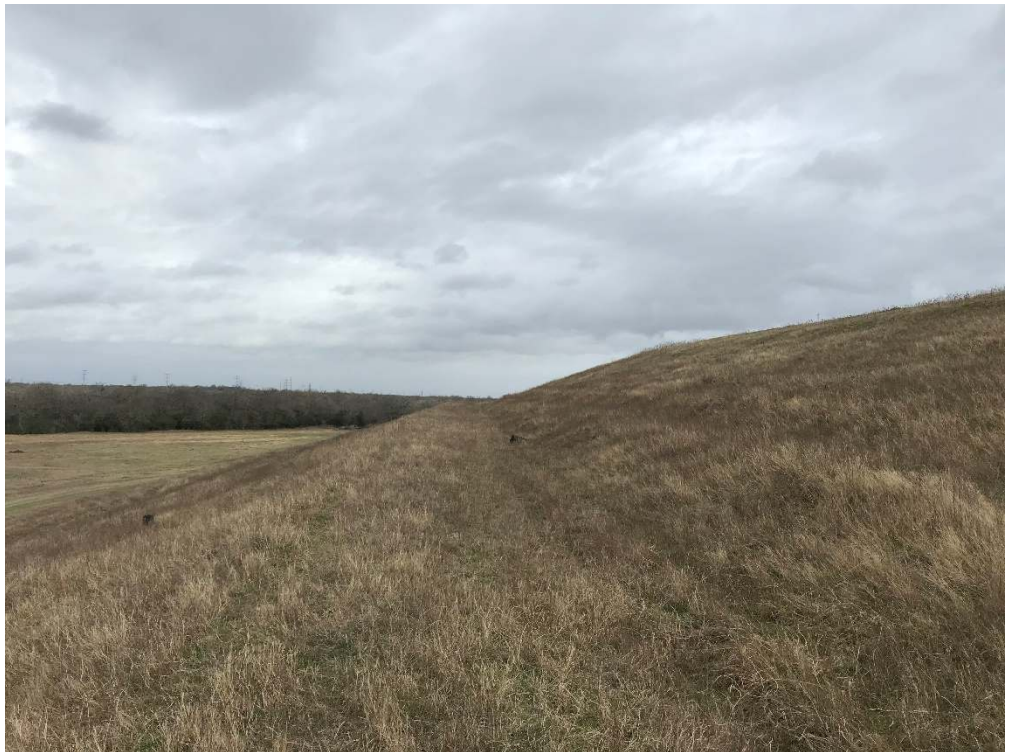
Facility: SFL Cover Area Embankment Slopes	
Photo No.: 18	Date: 01/09/2020
Photo Direction: NE	
Description: Typical photo of corrugated plastic tubes exposed at the toe of the benches. Inlets for these structures were not observed.
