2021 Site F Landfill Annual Inspection Report

Texas Municipal Power Agency
Gibbons Creek Steam Electric Station
Anderson, Texas
Project # 6703200070

2020 CCR Landfill Annual Inspection Report
Site F Landfill
Texas Municipal Power Agency
Gibbons Creek Steam Electric Station
Anderson, Texas

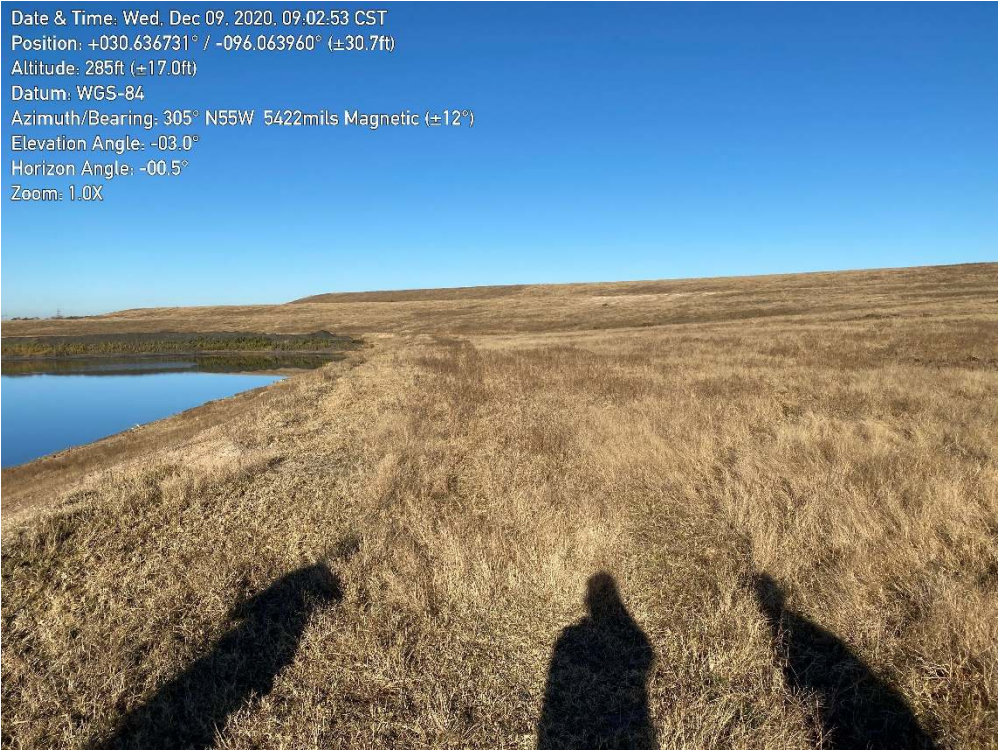
The ditch bordering the northeastern corner of the Active Area directs water to the stormwater detention area adjacent to the active area to the southwest. Erosion rills were observed on the downstream side of the stormwater berm at the northeast corner of the Active Area (Appendix 2, Photo 2 and Photo 3). The swale in this area is not well defined and should be regraded to adequately capture runoff and prevent further erosion.

<p>Photo No.: 3 Date: 12/9/2020</p>	
<p>Photo Direction: NW</p>	
<p>Description: Photograph of drainage berm along northern portion of Pond 3. Diversion berm not well defined, as evidenced by erosion rills observed below this area (See Photo 2).</p>	
<p>Structure: SFL Embankment Exterior Slopes</p>	<p>Date & Time: Wed, Dec 09, 2020, 09:21:42 CST Position: +030.637465° / -096.063520° (±15.8ft) Altitude: 305ft (±10.7ft) Datum: WGS-84 Azimuth/Bearing: 093° S87E 1653mils Magnetic (±10°) Elevation Angle: +01.5° Horizon Angle: -00.9° Zoom: 1.0X</p>  
<p>Photo No.: 4 Date: 12/9/2020</p>	
<p>Photo Direction: E</p>

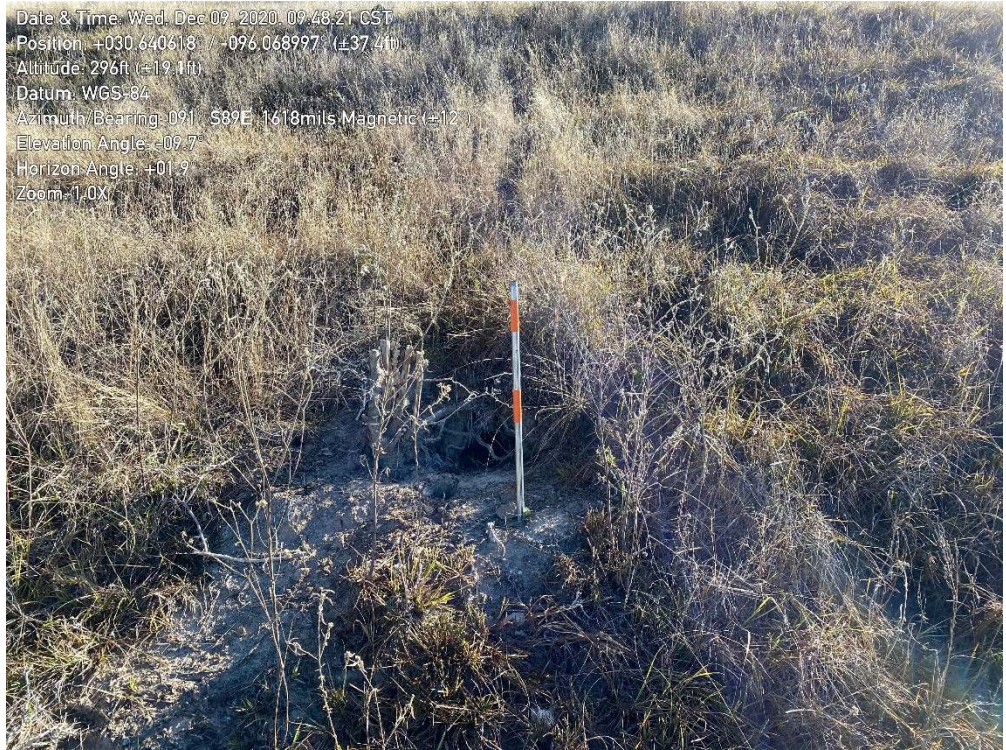
Animal activity (primarily animal burrows and cow paths) was observed at various locations along the landfill. TMPA has taken measures to mark the location of existing animal burrows for monitoring and future repair (Appendix 2, Photo 7 and 8). We recommend that the burrows be filled with compacted soil, cement grout, or other impermeable material to prevent progression into the embankment. Future burrows should be addressed in a timely fashion as they are observed.

Structure: SFL Cover Area Embankment Slopes	
Photo No.: 7	Date: 12/9/2020
Photo Direction: E	
Description: Typical condition of animal burrows onsite. Photo shows markings used to monitor locations of animal burrows and designate areas to be repaired.

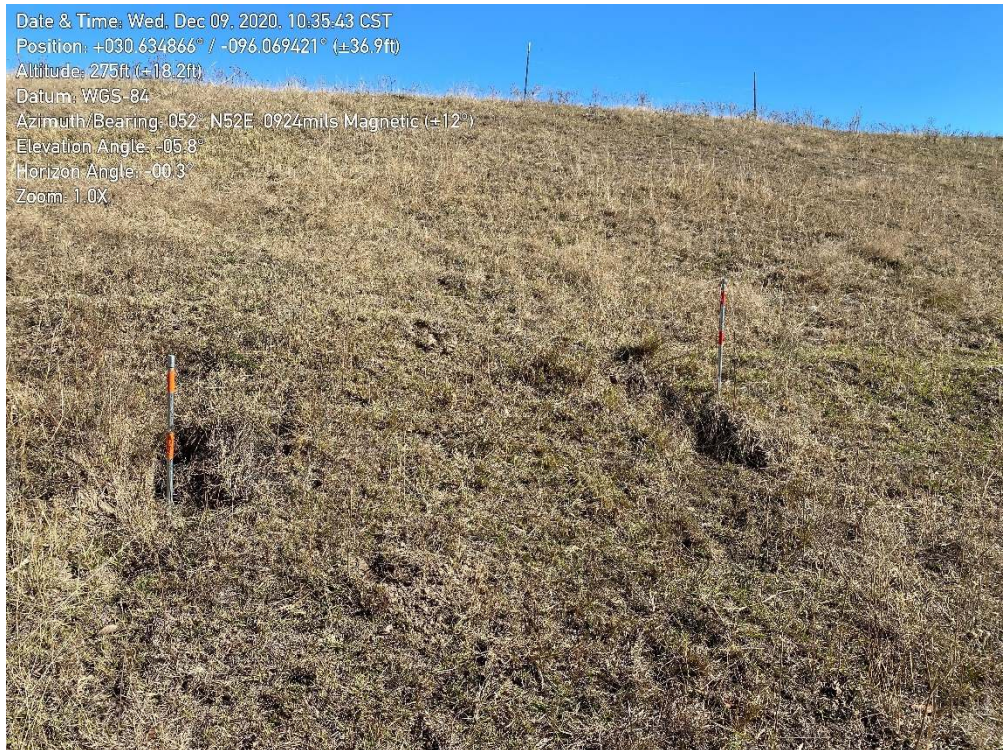
Structure: AFL Active Area Exterior Embankment	
Photo No.: 8	Date: 12/9/2020
Photo Direction: NE	
Description: Typical condition of animal burrows and markings used to monitor locations.

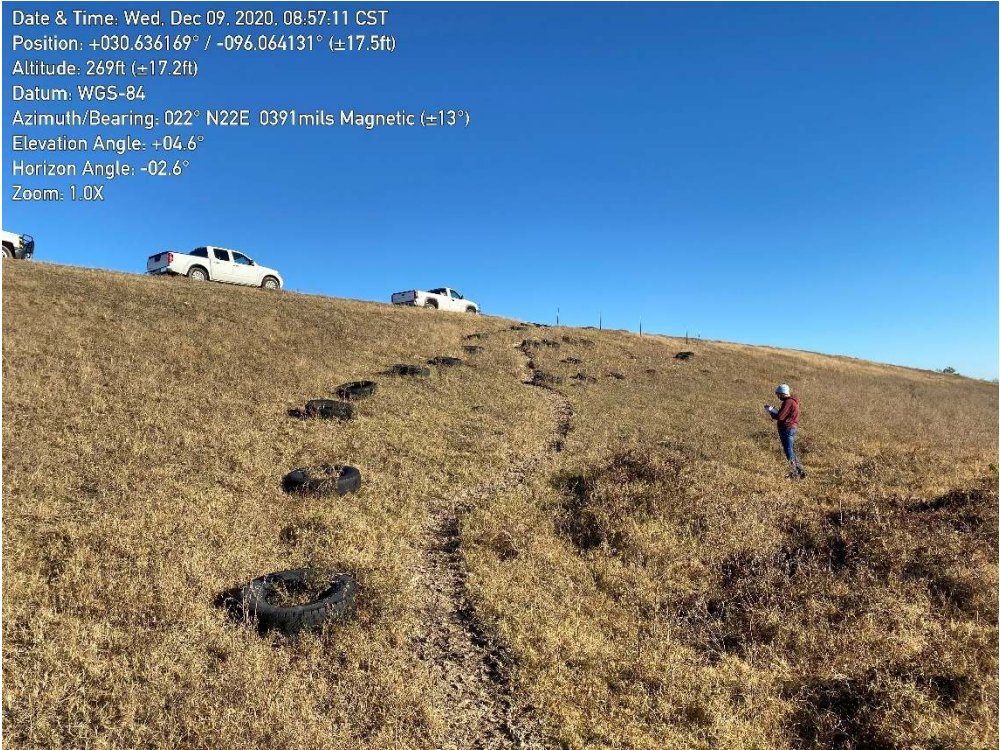
Photo No.: 9 **Date:** 12/9/2020

With regard to cow paths, current efforts are in place to force the cows to change paths periodically to avoid deterioration of the vegetation along these paths (Appendix 2, Photo 9). Remedial efforts were observed in the form of tires, and barbed wire across existing paths. These efforts appear to be an effective method to redirect cows. In addition to the current fixes, we recommend that these areas of previous cow paths continue to be re-graded and seeded to promote soil growth and prevent erosion in areas with exposed soil once the barriers are relocated.

Description:
 Typical animal activity, indicative of cow paths observed at various location on the embankment slopes. Shows current system used to redirect cows away from trodden paths. Tires and barbed wire periodically relocated to force new route.

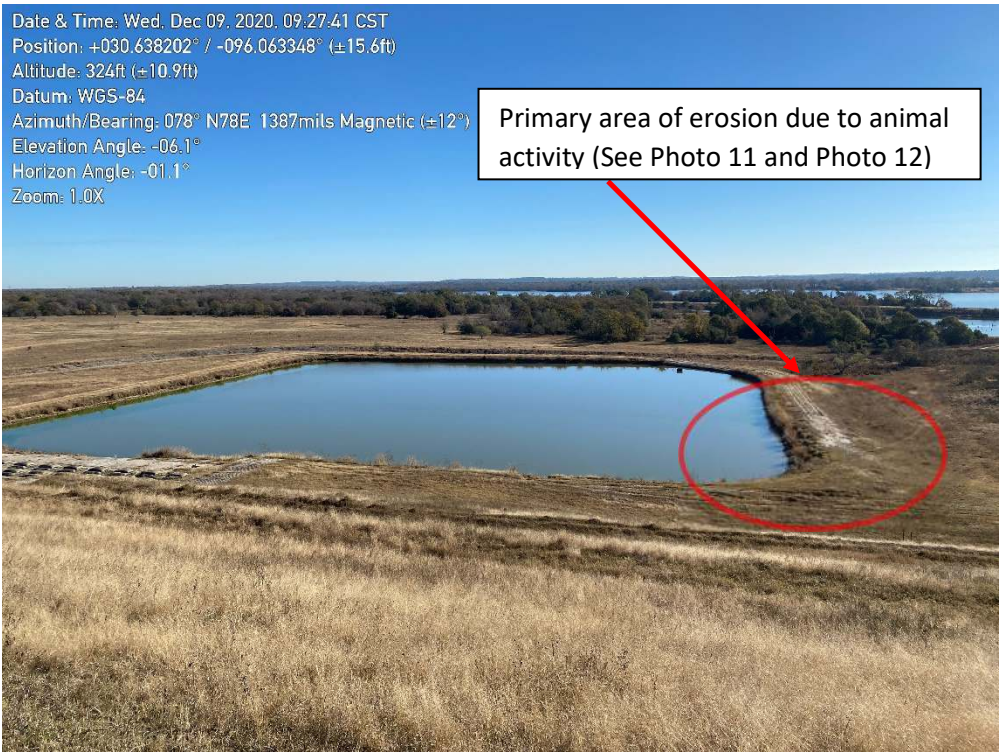
Photo No.: 10 **Date:** 12/9/2020

Description:
 Stormwater pond overview.

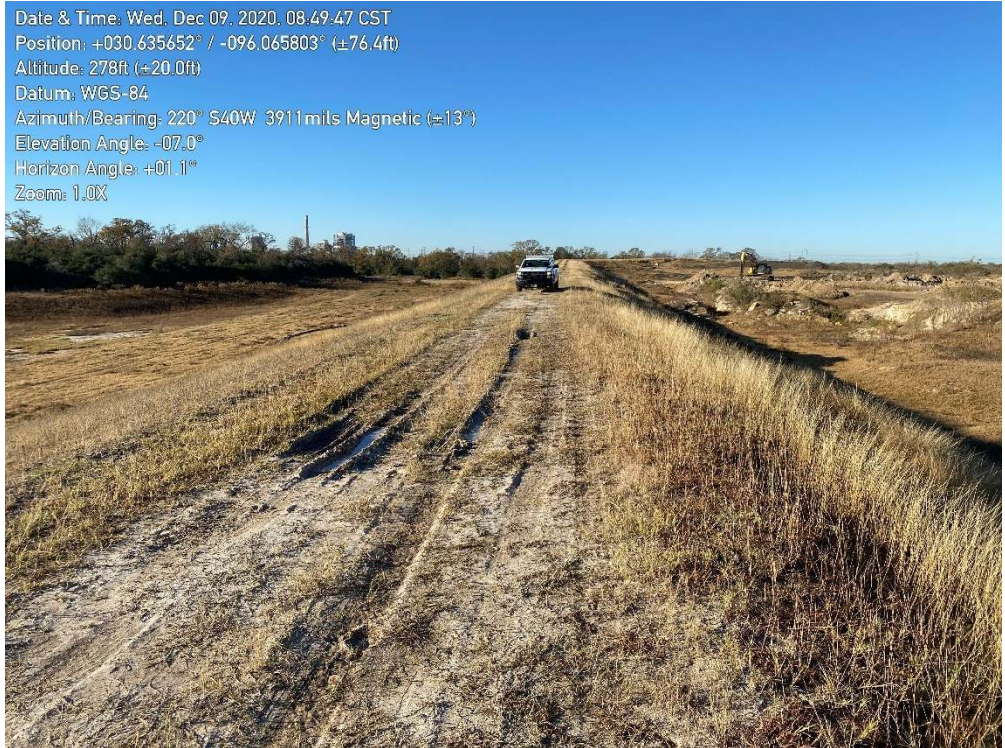
Photo No.: 13 **Date:** 12/9/2020

The access roads and cover area were observed to be in a well-maintained condition. One area of rutting was observed on the access road bordering the southeast side of SFL Pond 3 (Appendix 2, Photo 13). This area should be backfilled, compacted, and regraded to prevent water from ponding at the crest of the embankment.

Description:
 Rutting observed on access road bordering Pond 3 of the Active Area.

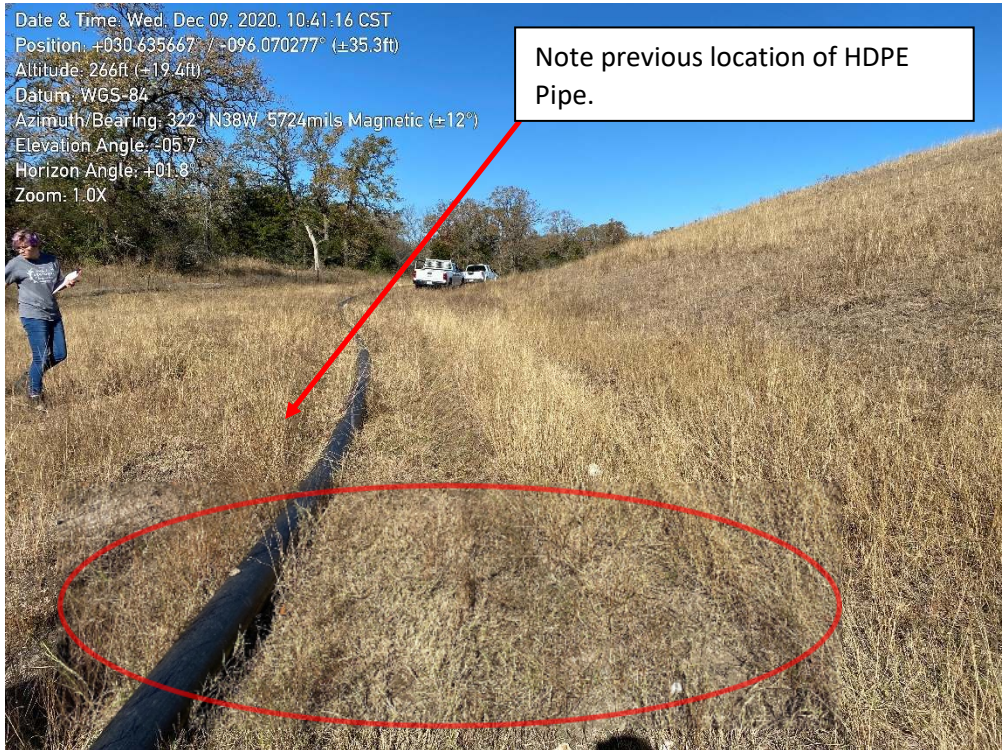
Photo No.: 14 **Date:** 12/9/2020

Description:
 Photograph of soft area noted at the toe of southern embankment. Possibly due to HDPE pipe relocation.

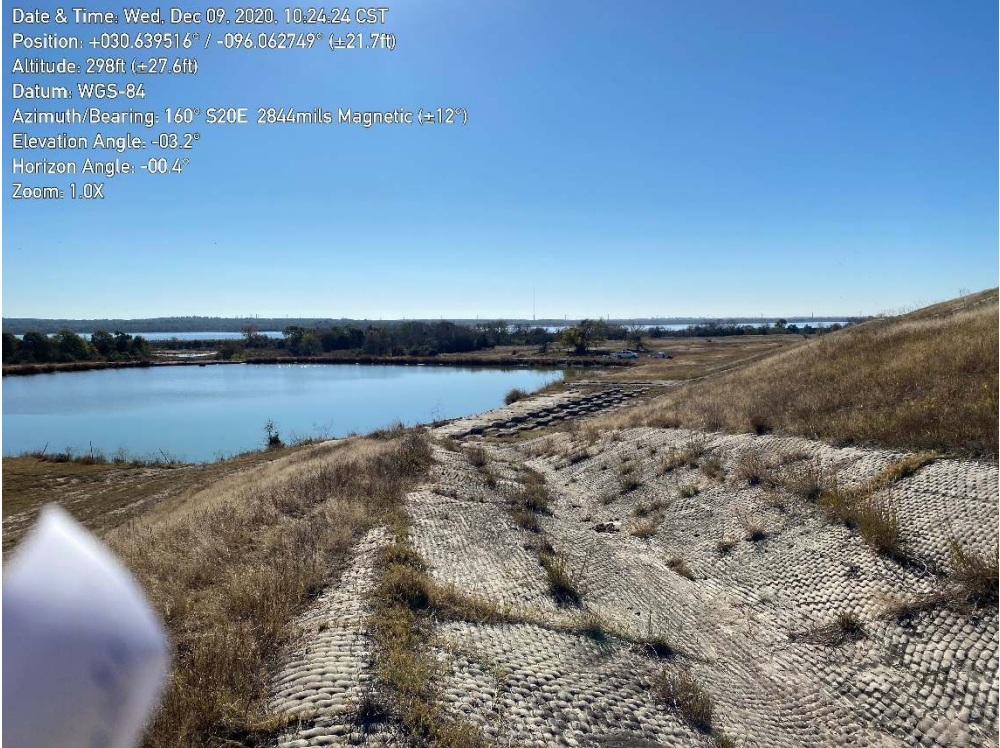
The stormwater management systems of the SFL appear to be in generally good working order. Stormwater management around the SFL consists of diversion berms and swales and concrete-lined spillways directing water from the Cover Area and diverting water from entering the Active Area. Stormwater is directed to Pond 1 and an unnamed stormwater retention area via concrete-lined spillways and drainage swales. Vegetation growing in portions of the concrete-lined spillways should continue to be removed as part of TMPA's routine maintenance operations (Appendix 2, Photo 16 and 17).

Structure: SFL Concrete Lined Drainage Channel	
Photo No.: 17	Date: 12/9/2020
Photo Direction: S	
Description: Typical condition of fabric-formed concrete drainage ditch. Vegetation observed in the concrete apron.
