Gibbons Creek Environmental
Redevelopment Group, LLC

2022 GIBBONS CREEK ANNUAL CCR UNIT INSPECTION

Gibbons Creek Steam Electric Station

January 28, 2022

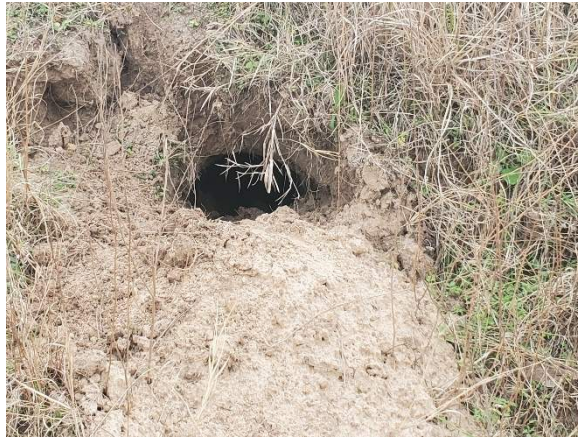
MODERATE ITEM: Animal burrows were found on the outside embankment of the landfill (Figure 2).

Figure 2: Typical Animal Burrow

Recommendation 1: Backfill burrows with compacted cohesive soil and reestablish vegetation. Lightly loosen uppermost soil during reseeding.

Recommendation 2: Continue to monitor restored areas for burrow damage or erosion.

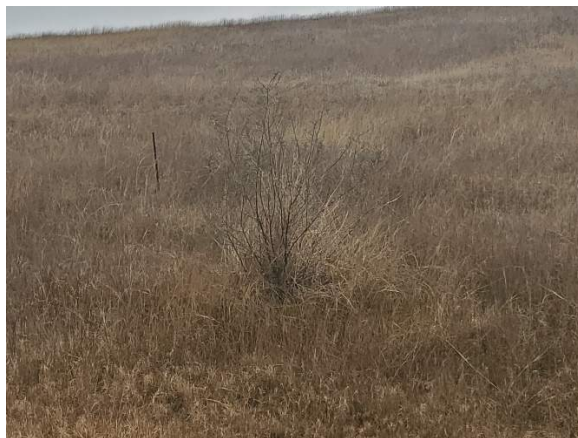
MODERATE ITEM: A small tree and some bushes were found growing on the cap of the Site F Landfill. The root systems of these plants could undermine the integrity of the cover and clay cap (Figure 3).

Figure 3: Typical Tree/Bush on Embankment

Recommendation 1: Remove bushes and trees on cap and repair areas disturbed during removal.

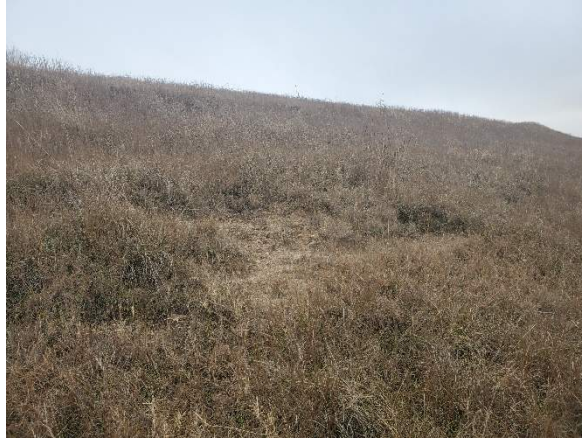
MODERATE ITEM: Erosion areas were forming along the outer embankment (Figure 4).

Figure 4: Side Slope Erosion

Recommendation 1: Backfill bare erosion gullies with compacted cohesive soil and reestablish vegetation.

Recommendation 2: Place riprap or stone in areas of concentrated flow.

Recommendation 3: Continue to monitor areas after repairs for additional erosion.

Recommendation 4: If erosion continues to be a problem at these areas after repair, construct down chutes at these areas to convey water off the closed area.

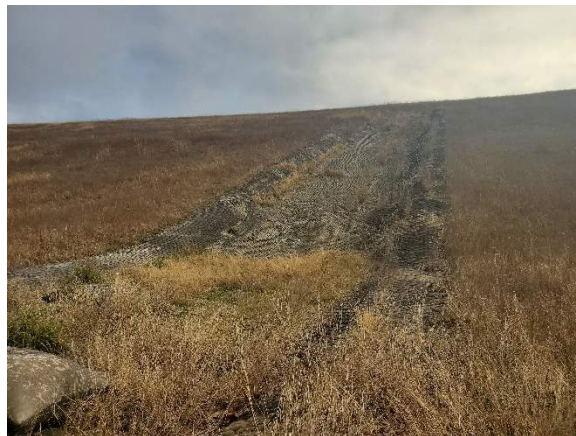
MINOR ITEM: Vegetation and sediment on concrete drop structures (Figure 5).

Figure 5: Vegetation and Sediment on Concrete Revetment

Recommendation 1: Remove vegetation and sediment as part of routine maintenance.

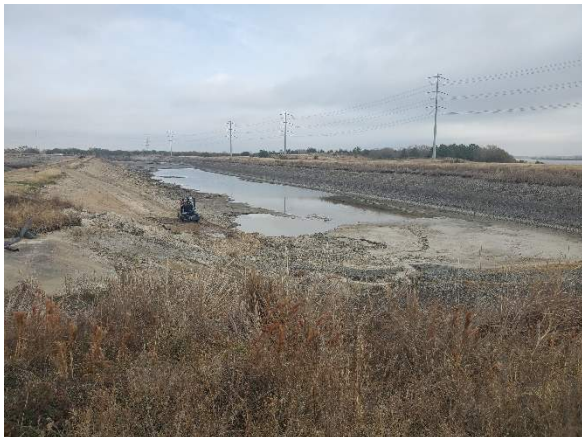
Figure 6: Ash Pond A

In general, the perimeter containment dike exterior and crest of the Ash Ponds appeared to be in good condition. No leaks or seepages were noted around the exterior of the ponds.

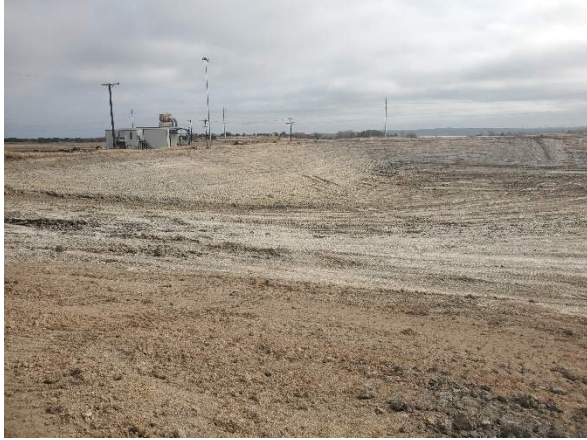
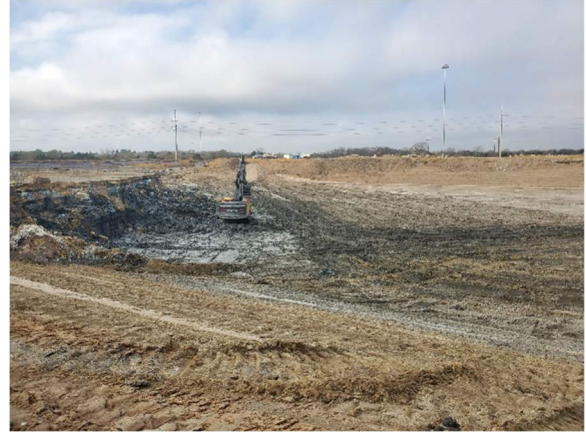
The Scrubber Sludge Pond is currently being closed through the “closure by removal” process (see Figures 9 and 10). The CCR material is being excavated from the pond and hauled to the Site F Landfill for disposal. The material is being placed in the active area of the Site F Landfill. After the CCR material has been removed, a final visual inspection will be performed on the pond to confirm the material has been removed and a closure certification will be issued. The Scrubber Sludge Pond is currently scheduled for closure completion in March 2022.

Figure 9: Scrubber Sludge Pond CCR Removal

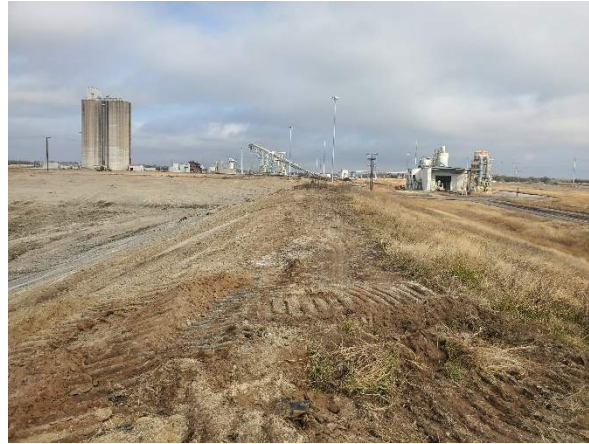
In general, the perimeter containment dike exterior and crest of the Scrubber Sludge Pond appeared to be in good condition (see Figure 11). No leaks or seepages were noted around the exterior of the ponds.

Figure 11: Scrubber Sludge Pond Containment Dike Status (typical)
