Gibbons Creek Environmental
Redevelopment Group, LLC

2023 GIBBONS CREEK ANNUAL CCR UNIT INSPECTION

Gibbons Creek Steam Electric Station

February 10, 2023

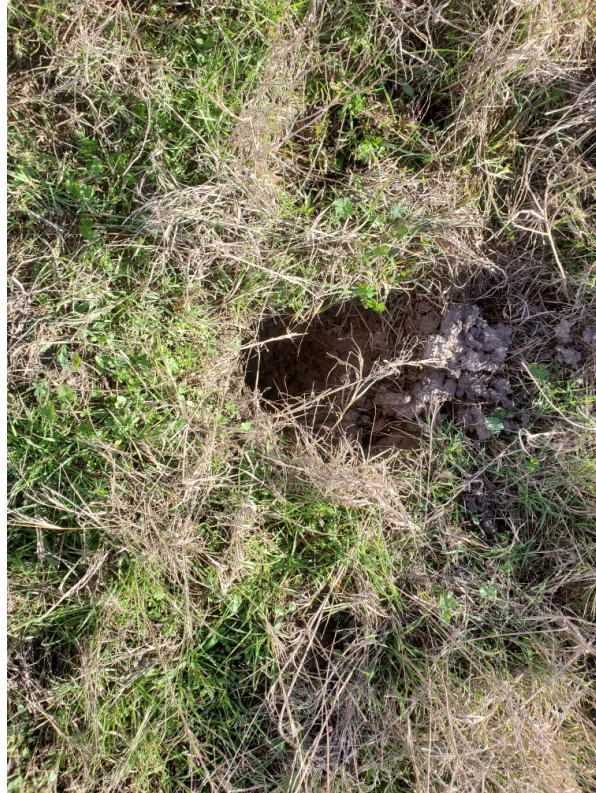
MODERATE ITEM: Animal burrows were found on the outside embankment of the landfill (Figure 2).

Figure 2: Typical Animal Burrow

Recommendation 1: Backfill burrows with compacted cohesive soil and reestablish vegetation. Lightly loosen uppermost soil during reseeding.

Recommendation 2: Continue to monitor restored areas for burrow damage or erosion.

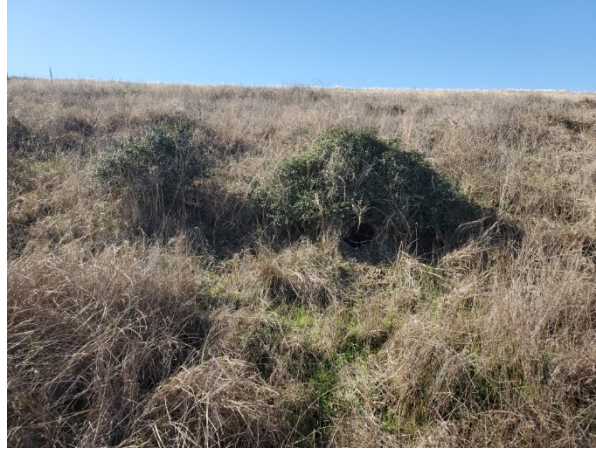
MODERATE ITEM: A small tree and some bushes were found growing on the cap of the Site F Landfill. The root systems of these plants could undermine the integrity of the cover and clay cap (Figure 3).

Figure 3: Typical Tree/Bush on Embankment

Recommendation 1: Remove bushes and trees on cap and repair areas disturbed during removal.

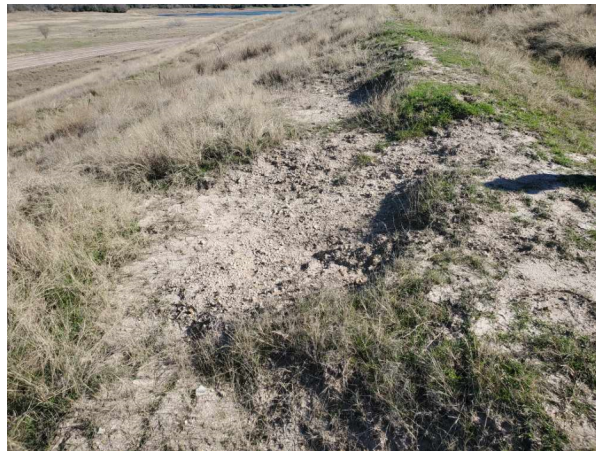
MODERATE ITEM: Erosion areas were forming along the outer embankment (Figure 4).

Figure 4: Side Slope Erosion

Recommendation 1: Backfill bare erosion gullies with compacted cohesive soil and reestablish vegetation.

Recommendation 2: Place riprap or stone in areas of concentrated flow.

Recommendation 3: Continue to monitor areas after repairs for additional erosion.

Recommendation 4: If erosion continues to be a problem at these areas after repair, construct down chutes at these areas to convey water off the closed area.

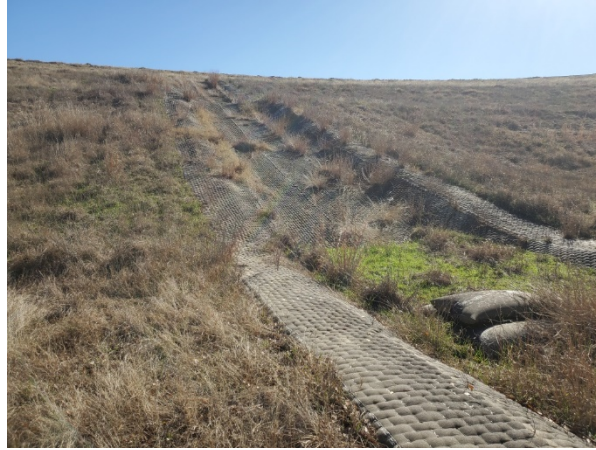
MINOR ITEM: Vegetation and sediment on concrete drop structures (Figure 5).

Figure 5: Vegetation and Sediment on Concrete Revetment

Recommendation 1: Remove vegetation and sediment as part of routine maintenance.

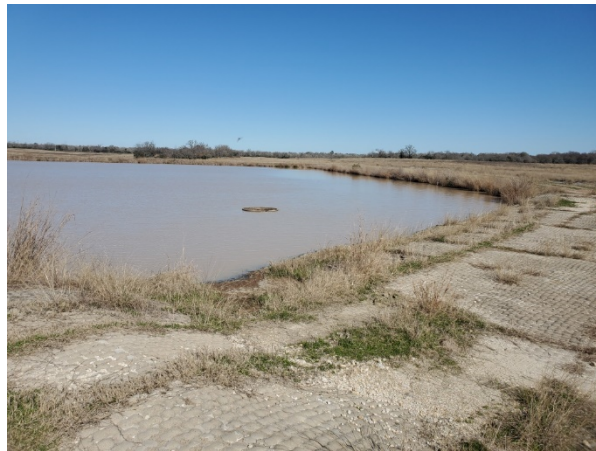
MODERATE ITEM: Some erosion control BMPs need maintenance.

Figure 6: Settling Pond Cloudy

Recommendation 1: Dredge and remove sediment in pond to improve its efficiency.

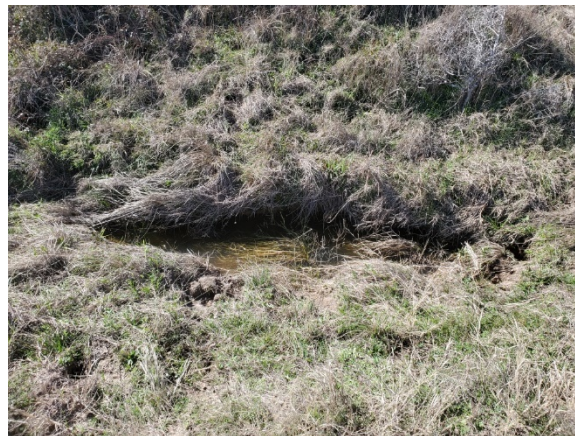
MINOR ITEM: Some areas with ponded water on landfill.

Recommendation 1: Backfill low areas with compacted cohesive soil, grade to drian, and reestablish vegetation.
