2020 Site F Landfill Annual Inspection Report

Texas Municipal Power Agency
Gibbons Creek Steam Electric Station
Anderson, Texas
Project # 6706190003.70

2020 CCR Landfill Annual Inspection Report
Site F Landfill
Texas Municipal Power Agency
Gibbons Creek Steam Electric Station
Anderson, Texas

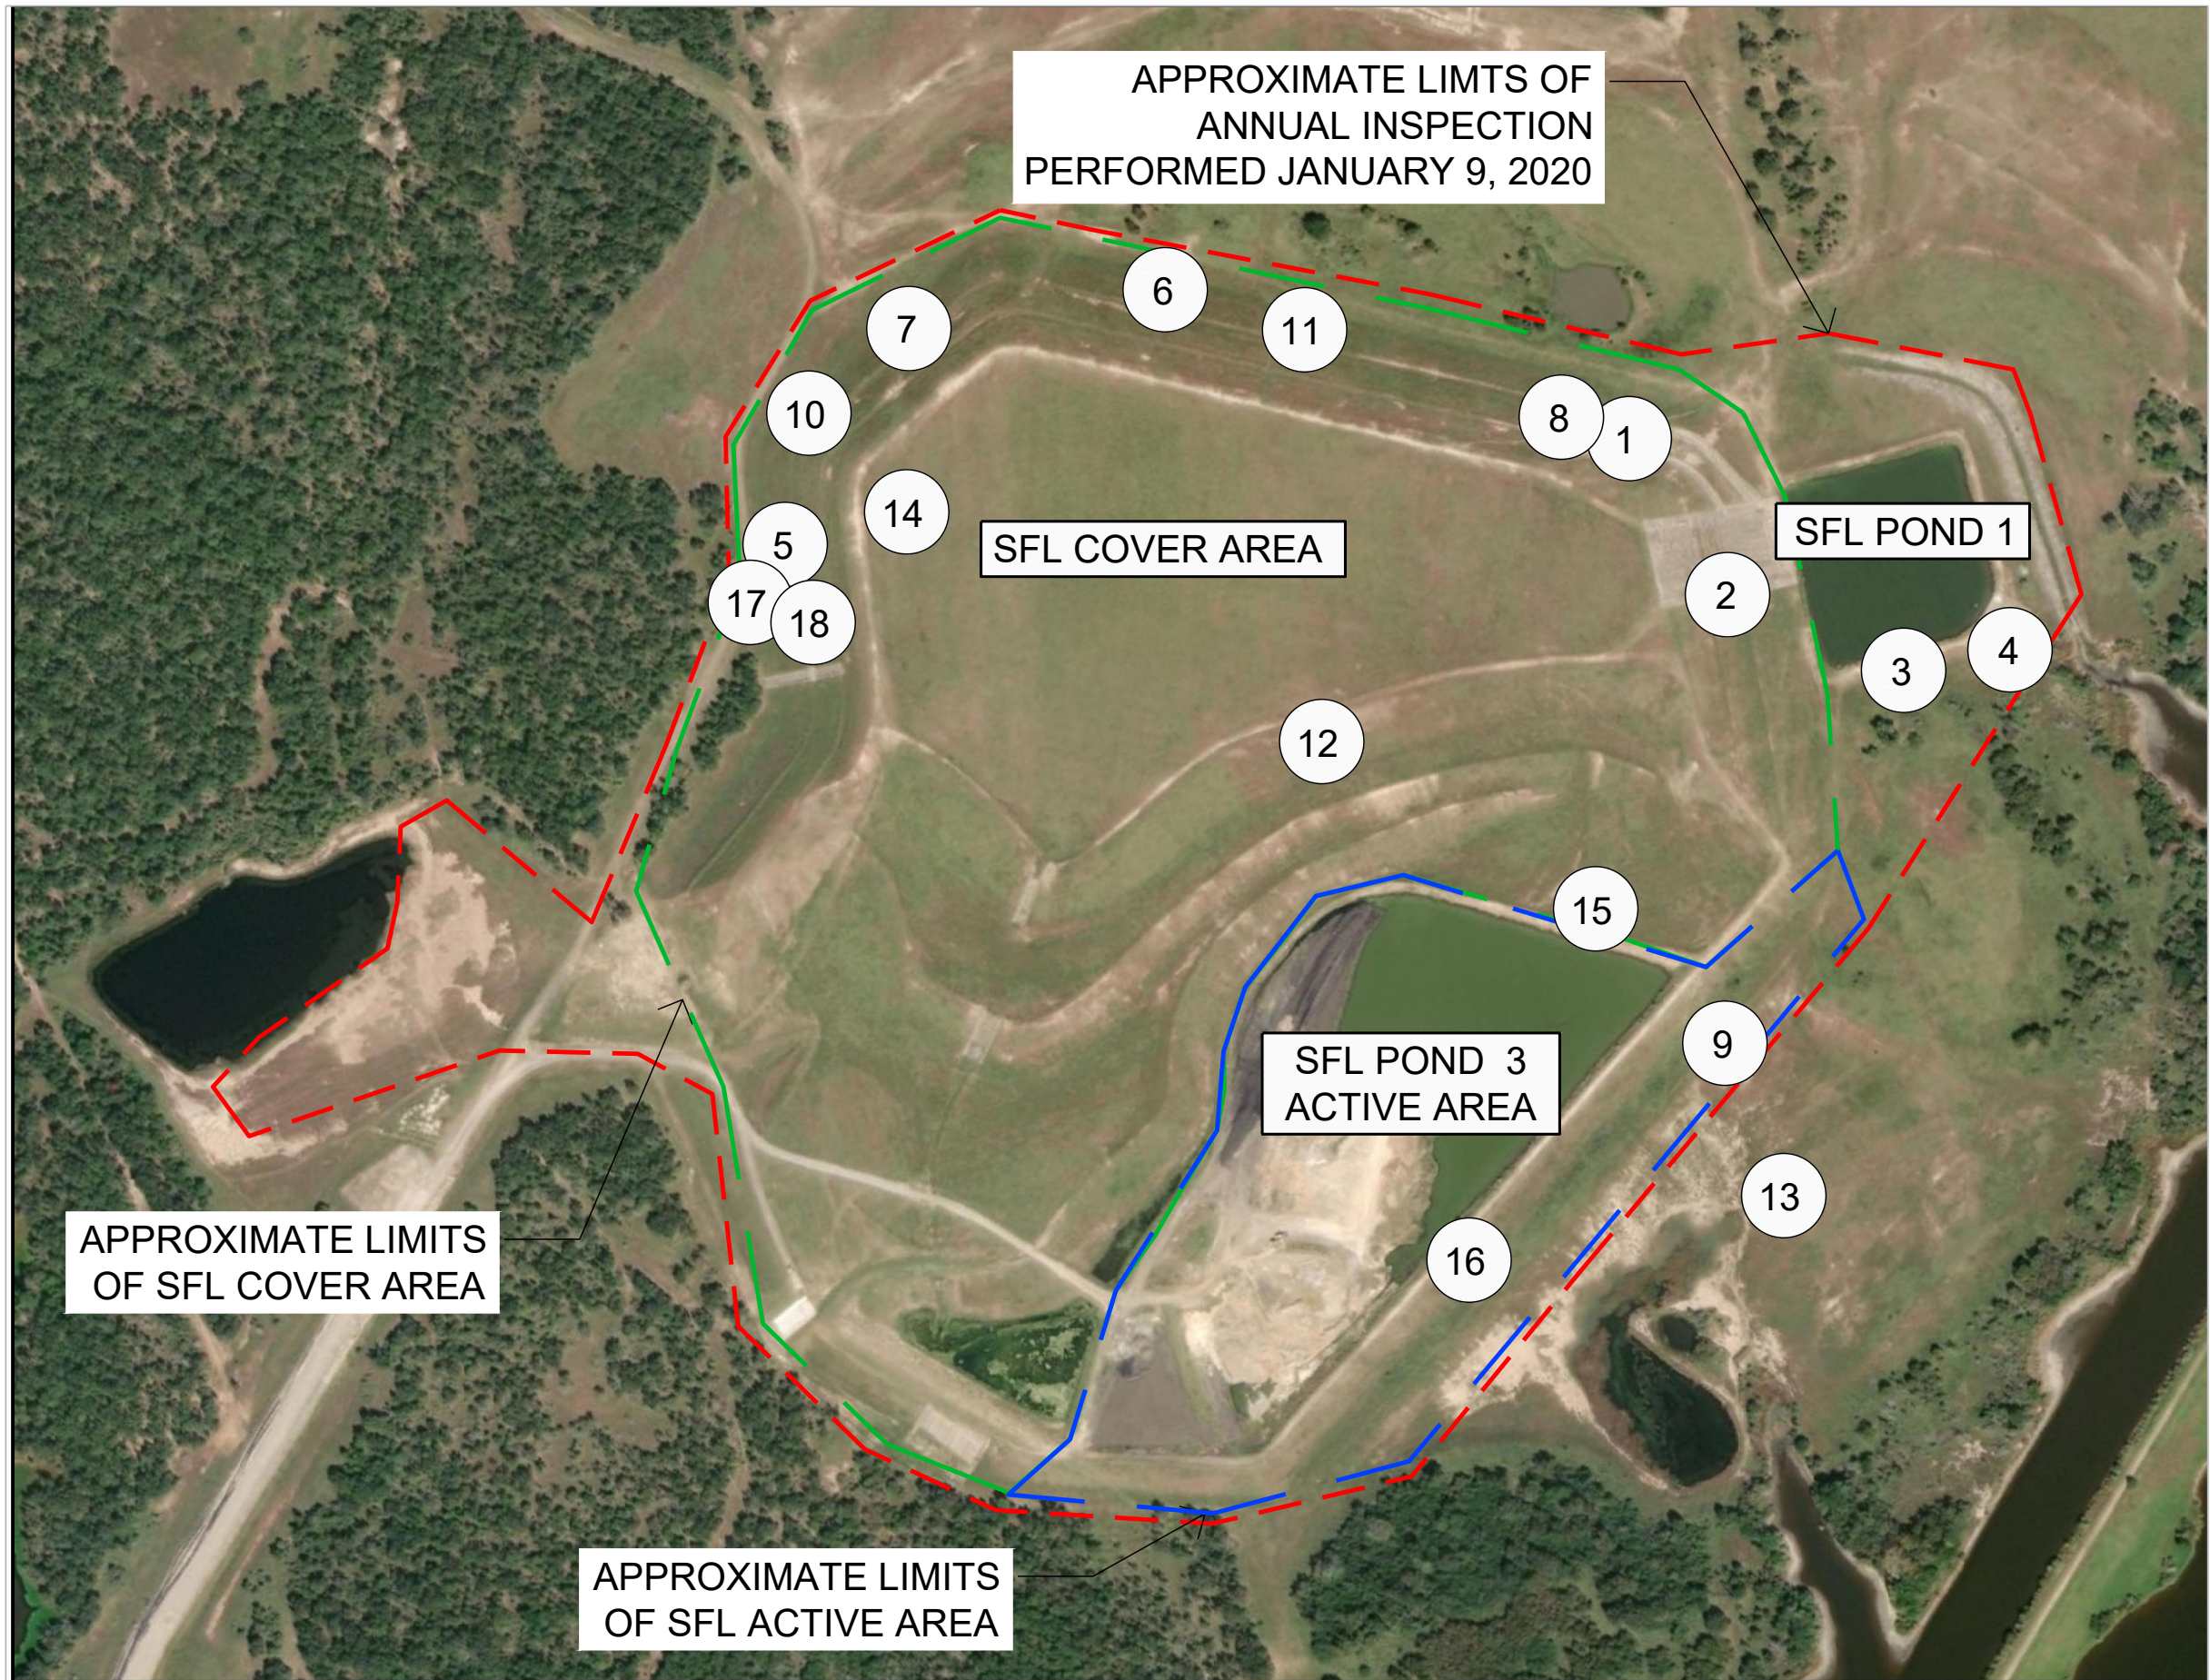
Landfill Component		Observed	Comment No.
Liner		No	---
Temporary or Permanent Soil Cover		Yes	4
Storm Water Control	Concrete Lined Stormwater Drainage	Yes	1,4
	Drainage Swales	Yes	---
	SFL Pond 1	Yes	2
Cover Area Slopes	Landfill Slopes	Yes	3,4,5,6
Active Area	Interior Slopes	Yes	4
	Exterior Slopes	Yes	3,4
	Impounded CCR Material	Yes	---
Roads, Culverts		Yes	---

Comment No.	Description	Photo No.
1	Vegetation growing through the fabric formed concrete lining in drainage channels and stormwater spillways.	1, 2, 4
2	Minor erosion observed on the interior slopes of the SFL Stormwater Ponds.	3
3	Indicators of animal activity observed at various locations on the embankments of the Cover and Active Areas.	5, 6, 7, 8, 9
4	Erosional features observed at various locations on the exterior and interior embankments of the Cover and Active Areas.	10, 11, 12, 13, 14, 15
5	Minor woody vegetation growth on embankment slopes	16
6	Corrugated plastic pipes (approximately 18" diameter) observed at various locations at the toe of the bench slopes in the Cover Area. Soil and vegetation infilling observed at several locations.	7, 17, 18
